TEST REPORT

No. : XMIN2401000184CM01_EN

Sample Name : MIPOLAM AMBIANCE ULTRA

Test Item: Oil-Wet Inclining Platform Test

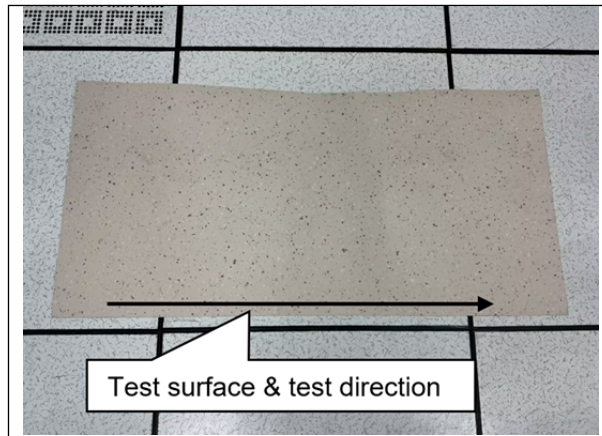
Original Sample Photo:

Sample Description: See photo

Specimen: 1000mm×500mm, 1pc, see photo

Test surface: see photo

Test direction: see photo

No.	Test Item	Test Method	Result
1	Oil-Wet Inclining Platform Test	AS 4586-2013 Amdt 1- 2017 Appendix D	Critical angle of inclination: 10.8° Classification: R10
